45132 Restoration and Preservation Magazine
Newsletter of the 45132 Supporters Group

Spring 2010 Edition

PROGRESS

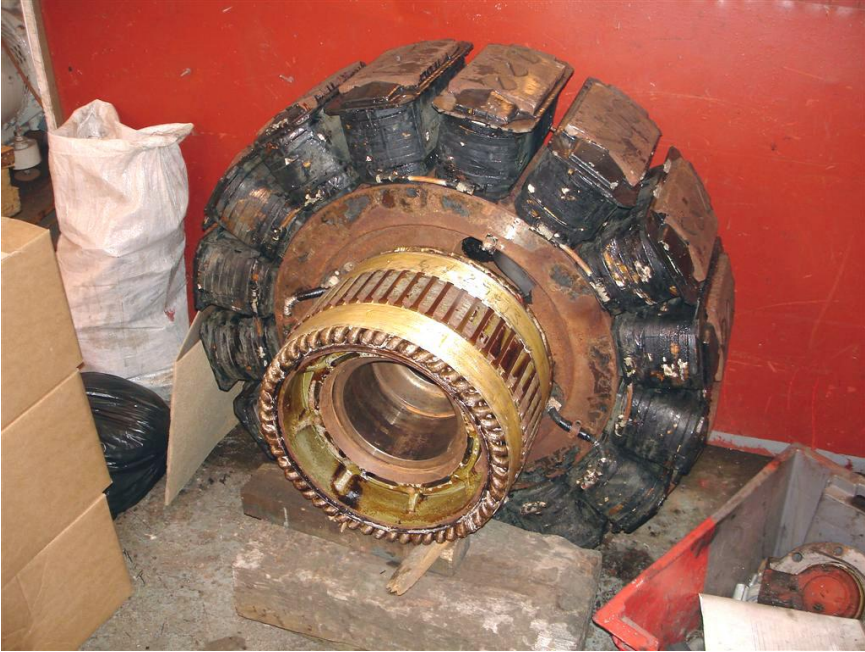
The Alternator Rotor separated from the main shaft. Photo by Mike Jacob.

As reported in the Winter Edition the Generator has been transferred to Bowers Ltd at Heanor in Derbyshire. Bowers were having problems separating the Alternator Rotor from the main armature shaft. We are pleased to report that this was successfully accomplished. They obtained advice from someone who used to work in Derby Works. It involved injecting glycerine under high pressure (reported as 40,000psi!) into the joint and then barring back the rotor with a few hefty hammer blows which resulted in it being successfully separated and there was no damage to the shaft or rotor.

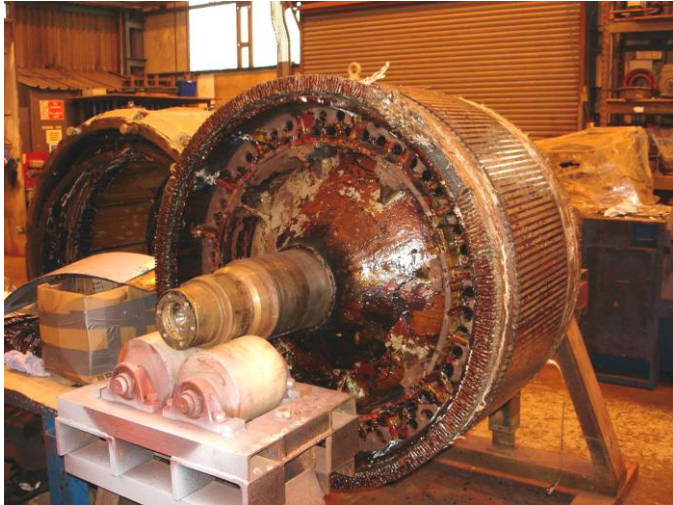
The damaged Armature, minus the Alternator Rotor, on Stands. Photo by Mike Jacob.

The picture captions should explain how the damaged armature windings are being prised back. Dave Hesketh of Bowers is now looking at whether they can butt braze new end pieces to each of the windings. It will be quite a tricky job, but if successful it will avoid having to extract the entire winding coils, and should save a lot of time and effort.

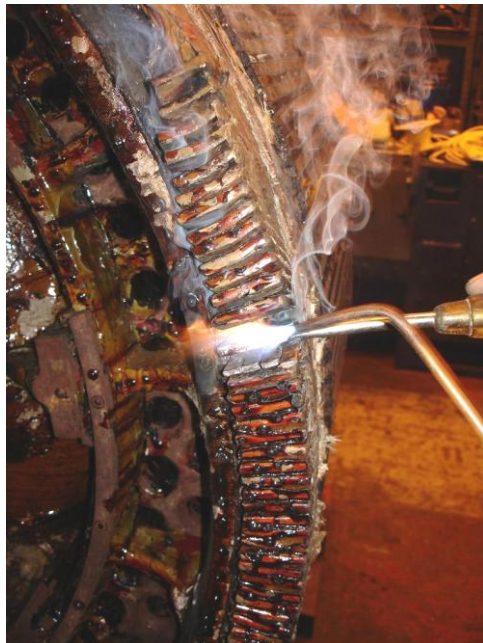
Melting off brazing connecting ends of windings. Photo by Mike Jacob.

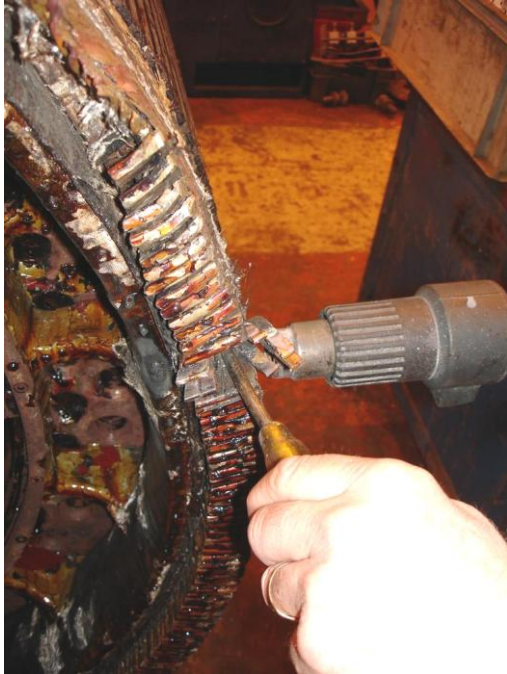
Heat-gun softens up the windings to ease prising them out. Photo by Mike Jacob.

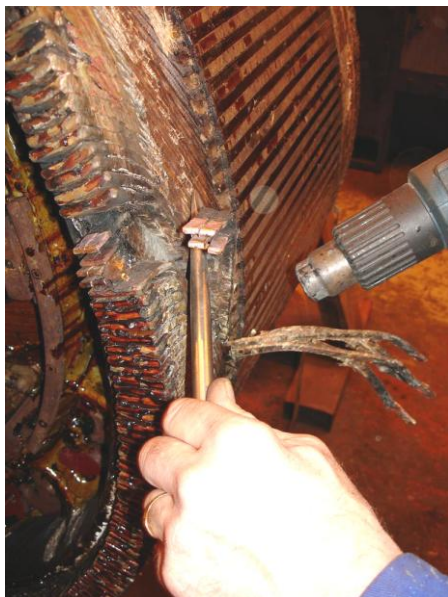
Top windings being prised out. Photo by Mike Jacob.

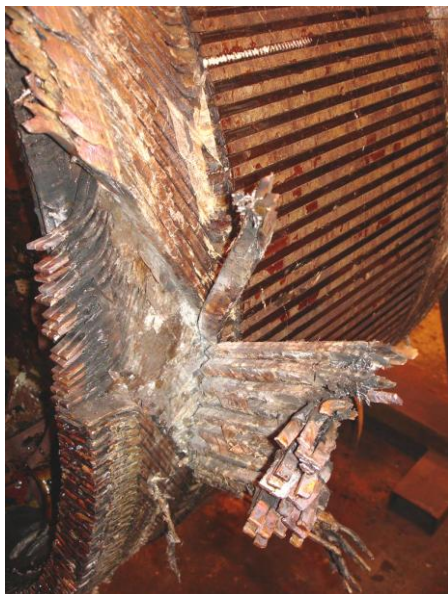
First set of top windings pulled back. Photo by Mike Jacob.

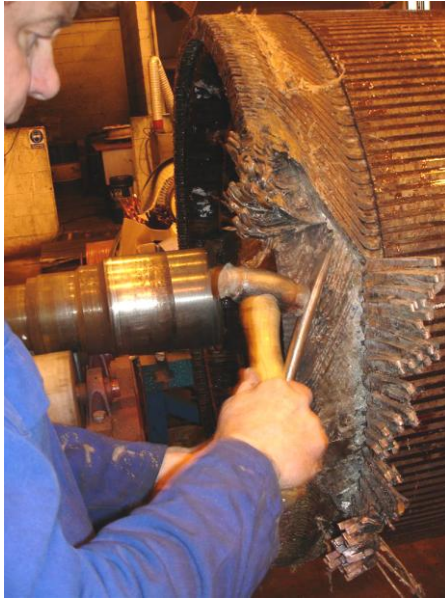
Damaged inner windings being knocked back. Photo by Mike Jacob.

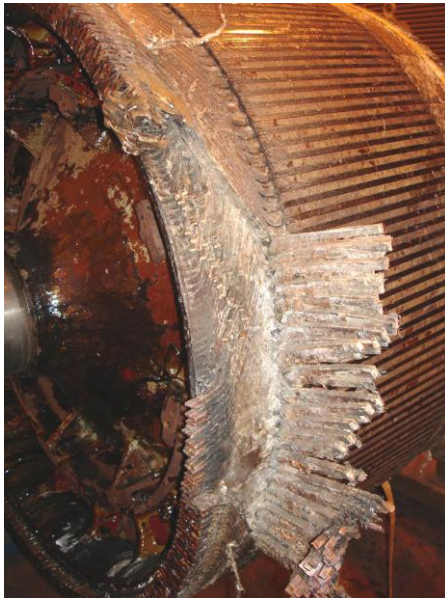
Majority of damaged windings now pulled back and ends cropped. Photo by Mike Jacob.

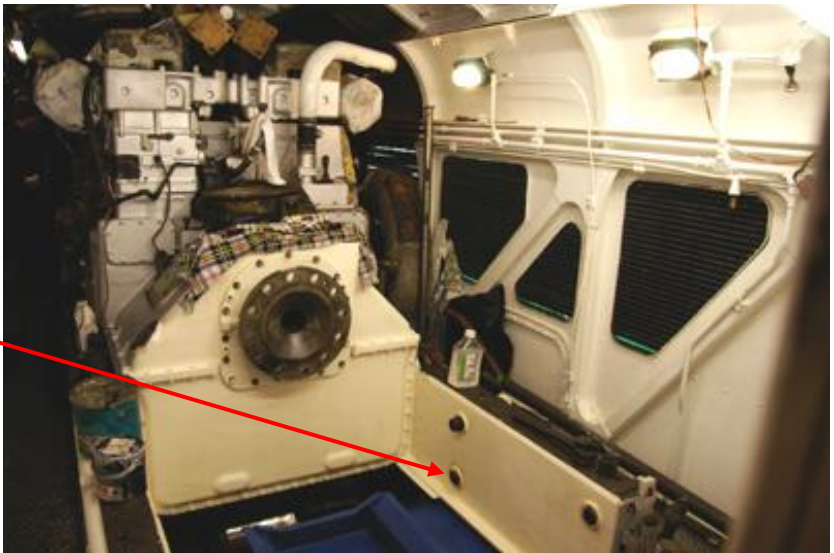
Last cross
slide
adjustment
bolt still in
situ

Engine, Gearbox and Interior 27th February. Photo by Mervyn Turvey.

Seven out of the eight cross slide adjustment bolts in the Generator Bedplates have now been removed but the last one remains stubbornly fixed in place. Even the special tool we made to release them has been damaged and is under repair. Currently the bolt is being soaked in oil whilst repairs and modifications to the special tool are undertaken.

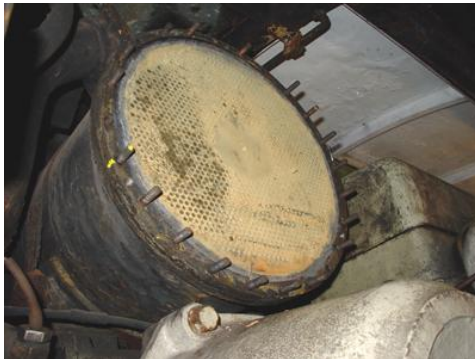
This unit resembles a small version of a steam loco boiler. It is effectively a cylinder through which pass numerous small tubes which carry the water that cools the surrounding engine lubricating oil.

Intercooler with end cover removed for cleaning.

This has been stripped of its end covers to allow cleaning and refurbishment. The filters and end covers have already been cleaned. We are currently devising a method of cleaning the many small tubes passing through it.

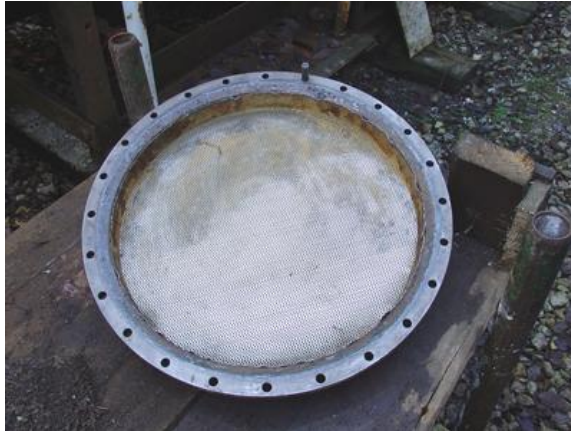
Intercooler end cover undergoing cleaning.

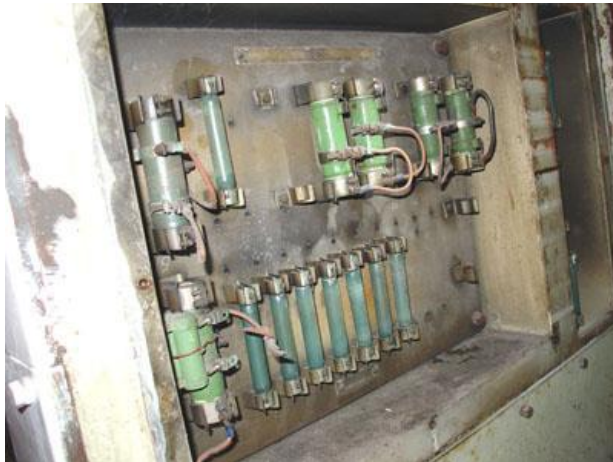
Various electrical clips that hold wire wound resistors in place have broken and those still intact appear ready to fracture at any time plus several variable resistors were in poor condition. Fortunately these are still available, a supplier has been found and replacements are now on order and due to be fitted soon.

Damaged resistors and clips that will need replacing.

Refurbishment of the Load Regulation resistor banks has commenced with all terminals being freed off, copper greased and reconnected.

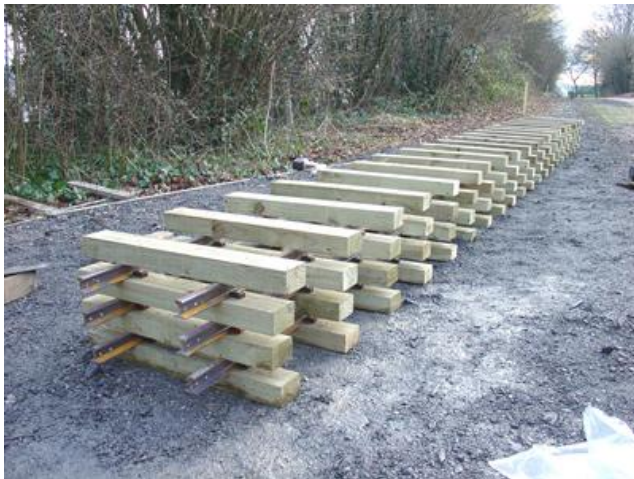
Track panel production 20th February.

The work in this area has been possible due to the dedicated efforts put in by group members Ray Briscall, James Churcher, Keith Hoddy, Martin Pratt, Dave Hill and myself. I arranged for materials to arrive in the correct order and times and then an effective production line system was initiated. This consisted of Keith aided by James, Martin or Dave pre-drilling pilot holes in almost 600 treated wooden sleepers using a specially made template. They also pre-drilled the ends of all the lengths of 6lb per yard flat-bottomed steel rail ready for the fishplates, again using a jig specifically designed for this task. Another 1 or sometimes 2 teams (myself, Ray, Martin and James) then assembled the track panels using gauges to control both sleeper spacing and maintain the correct 10¼” gauge throughout. The rails were secured to the sleepers by special plastic clips held in place by 40mm screws.

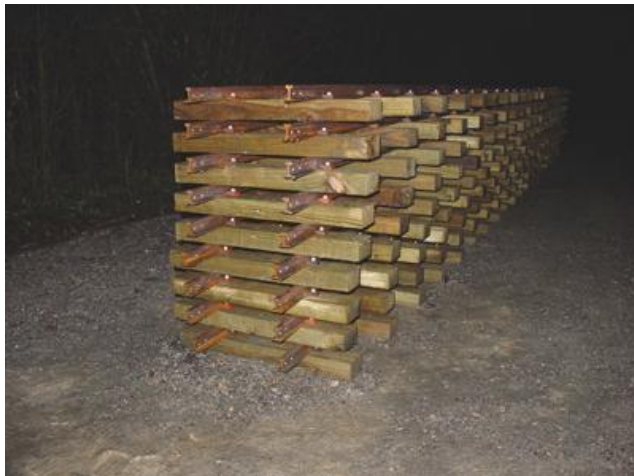
9 panels here and another 10 by the container meant 19 had been constructed as night closed in on Sunday 21st February!

Then the pace was stepped up and by the close of play the following Sunday (21st February) we had constructed 19 panels, which was enough to reinstate the majority of the line! This left approximately 7 more panels and two sets of points to complete the track construction. At the time of writing we are about to start track laying following a revised alignment being marked out with marker posts and a laser line.

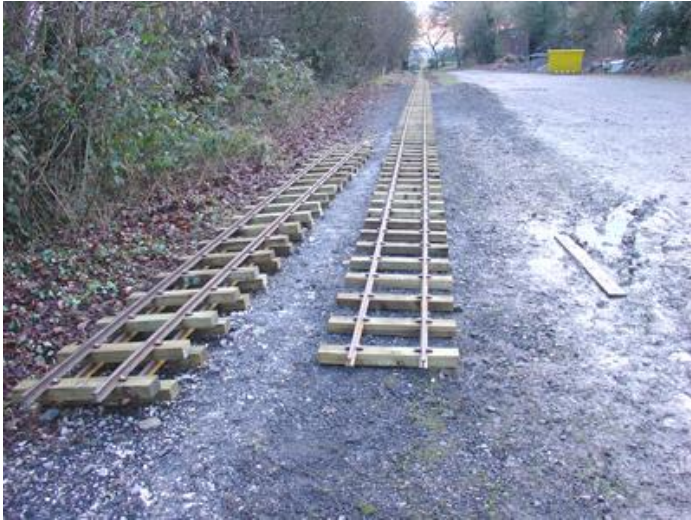
Track panels being placed in position 28th February.
